UPGRADING OF BOUNDARY DAM SPILLWAY

Gordon McPhail, P. Eng., KGS Group, Winnipeg, Manitoba, Canada
Justin Lacelle, P. Eng., SaskPower, Regina, Saskatchewan, Canada
Bert Smith, P. Eng., KGS Group, Winnipeg, Manitoba, Canada
Dave MacMillan, P. Eng., KGS Group, Winnipeg, Manitoba, Canada

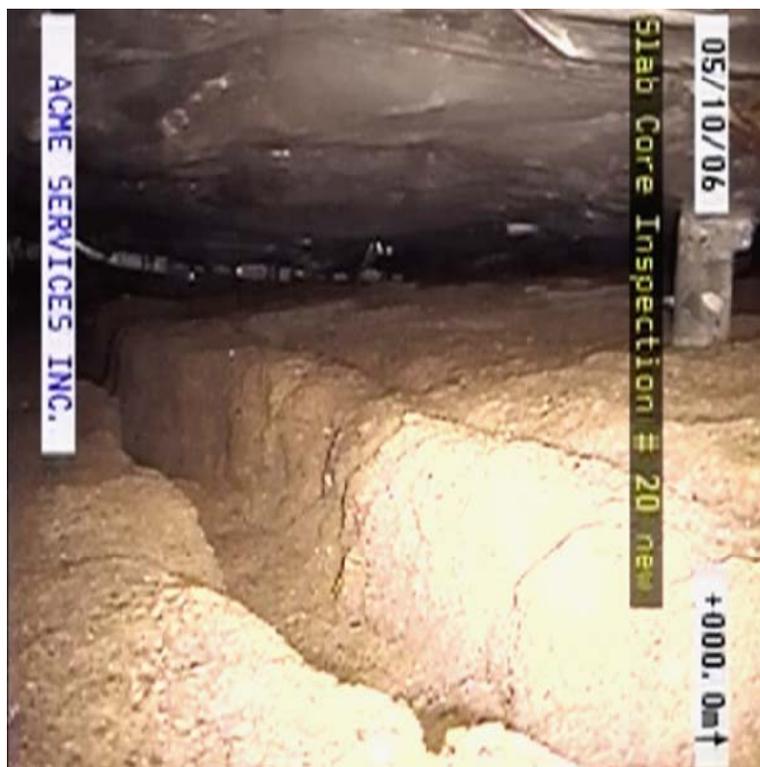
- Lower portions of the spillway had heaved vertically up to 400 mm despite belled hold down piles
- The upper spillway chute slabs are relatively thin (300 mm) and have no waterstops, and many of the slab joints had deteriorated due to freeze thaw
- The subsurface drainage system is critical to overall stability of the chute and the slabs, but had failed, with the drain pipes collapsed, infilled with coal dust fines and/or large stones, and many of the pipes were separated and now offset.
- As a result of the inflows from the slab joints and the failed drainage system, there were large eroded voids in the granular fill under the spillway slabs, up to 1 m deep by 10 m wide by 10 m long beneath the slabs (see Figure 2 below)
- the existing chute did not have sufficient discharge capacity, and required the basin be lowered and extended as well as the chute walls raised.

Figure 2: Void in granular beneath spillway chute slab. Note erosion channels and 150 mm diameter core in background, which was cored and dropped through void onto granular substrate.

To limit swelling of the complex foundation beneath the lower chute and basin (portions of the original spillway had swelled almost 400 mm vertically despite belled concrete holddown piles) the upgraded basin and lower chute are held down with over 480 post tensioned anchors extending up to 35 m below the slab. Given the many bentonite seams and challenging foundation conditions (including coal seams) beneath, the anchors were designed on the basis of results from an anchor test program performed under the direction of KGS Group in 2007, and include post-grouting strand anchors that are instrumented to verify their continued loads. In addition, the excavation was designed to extend below sensitive bentonitic seams to minimize future swelling below the basin. Construction depressurization of the low permeability foundation strata was determined to be critical during excavation to maintain the necessary minimum slope stability conditions, and to limit potential swelling.

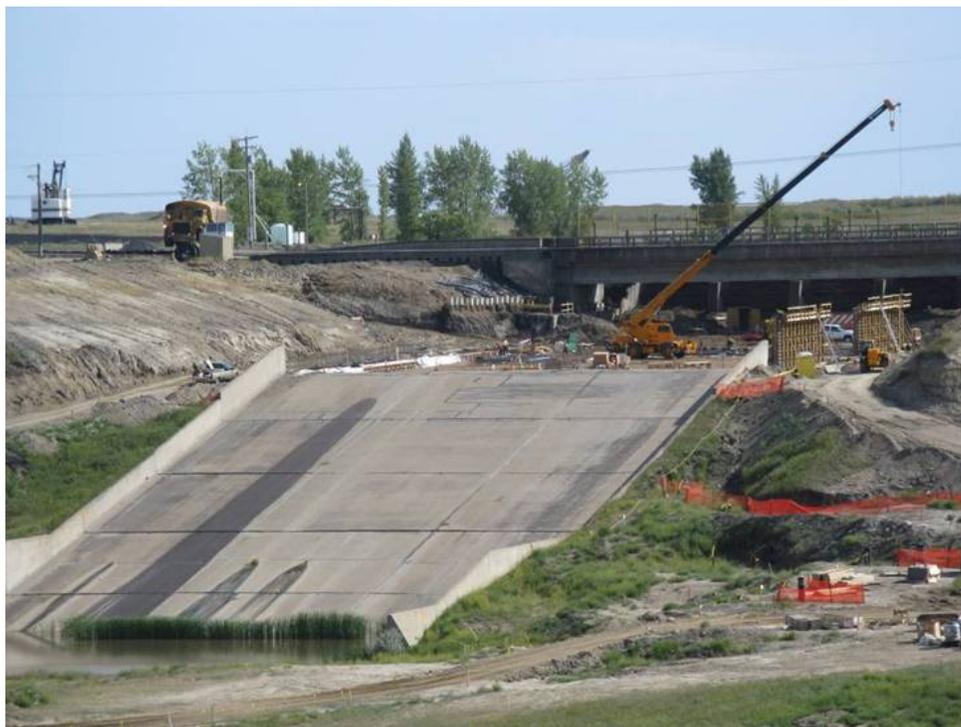
Figure 3: Phase I Work Underway in Summer of 2008.

Following review of the quotations from the three pre-qualified contractors, the work was awarded to PCL Construction Management Inc. The Phase I work commenced in the summer of 2008 with the removal and reconstruction of the spillway chute between the roadway crest and the start of the steep portion. The Phase I work was largely completed in December of 2008. The demolition and the construction of the Phase I work is presented in Figures 3 and 4.

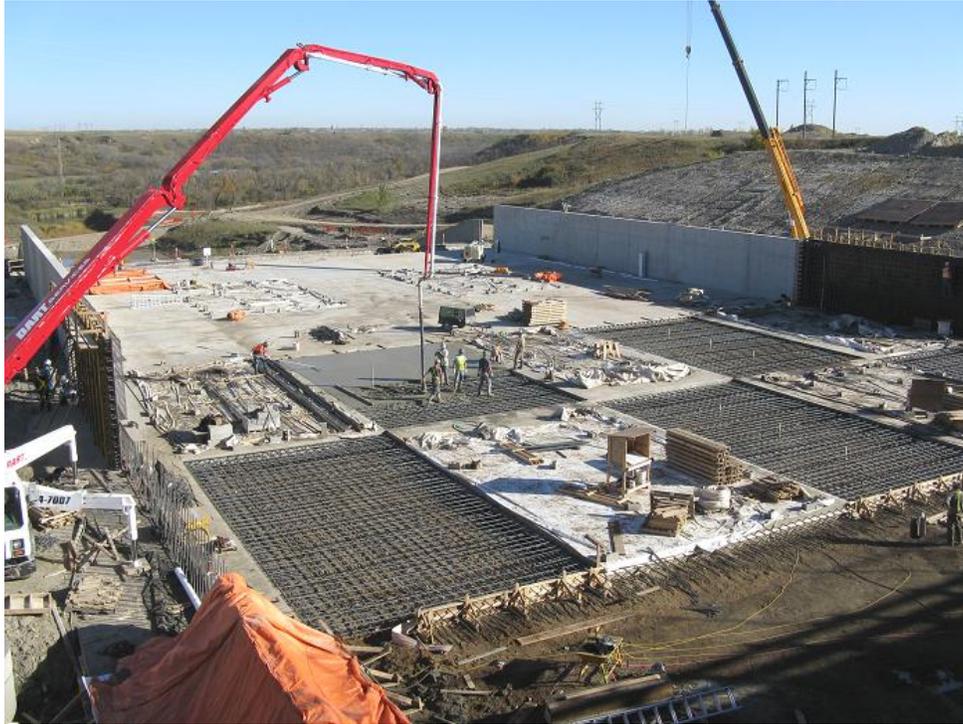
Figure 4: Phase I Spillway Chute Construction Underway in Summer of 2008

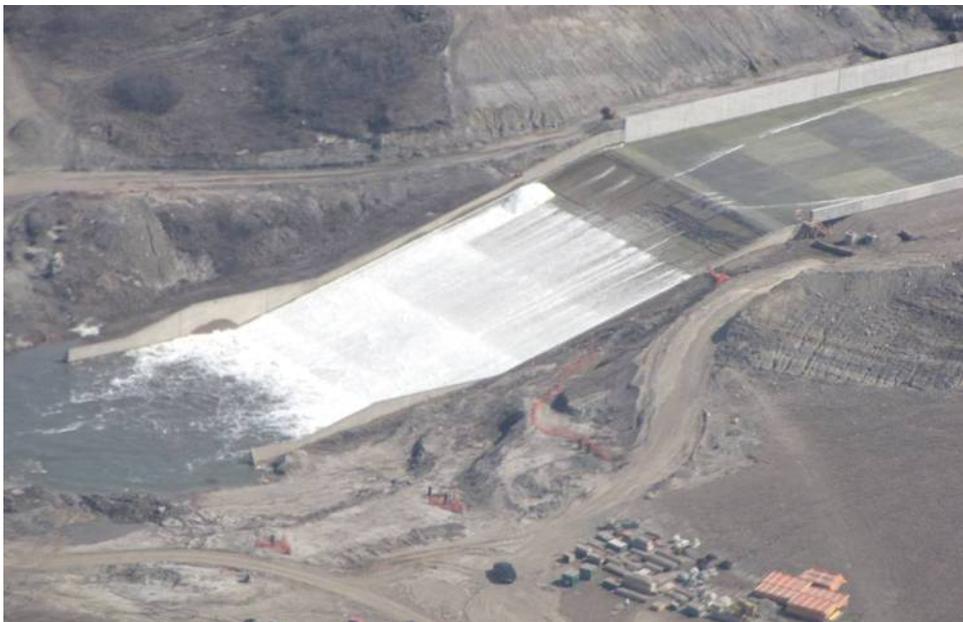
Figure 5: 2009 Spring Flood Passage Through Partially Replaced Spillway (Phase I / Existing)

- Phase I consisted of the replacement of the upper flatter portion with a new spillway with higher walls temporarily connected to the existing steep section and basin. This allowed for the passage of spring flood waters after completion of the Phase I work and before Phase 2, if required. As it turned out, this contingency was used as the spillway had to be operated for flood passage at the end of Phase 1 after not being operated for nearly 20 years. The contingency plans and measures developed to manage the water during such an event was seamlessly executed by the project team (see Figure 5).

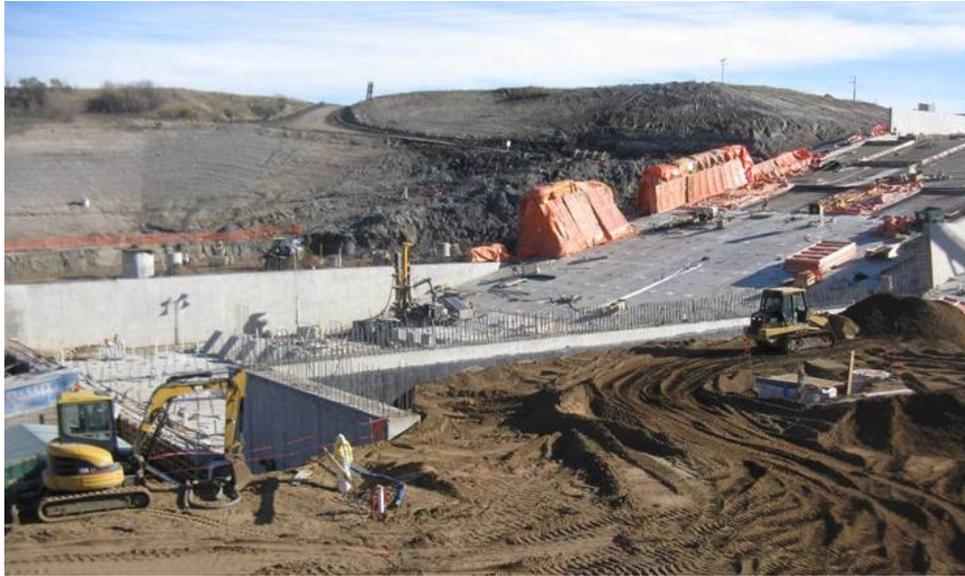
Figure 6: Phase 2 Spillway Chute and Basin Construction Underway in 2009

The Phase 2 work included the replacement of the steep portion and the new deeper and longer stilling basin. The work commenced in May of 2009, as work was delayed by the spring flood passage, and was substantially completed in April of 2010. Figure 6 presents the Phase 2 work underway in 2009, while Figure 7 presents the hoarding that proved necessary to allow the Phase 2 concrete and anchoring work to be completed by the spring of 2010.

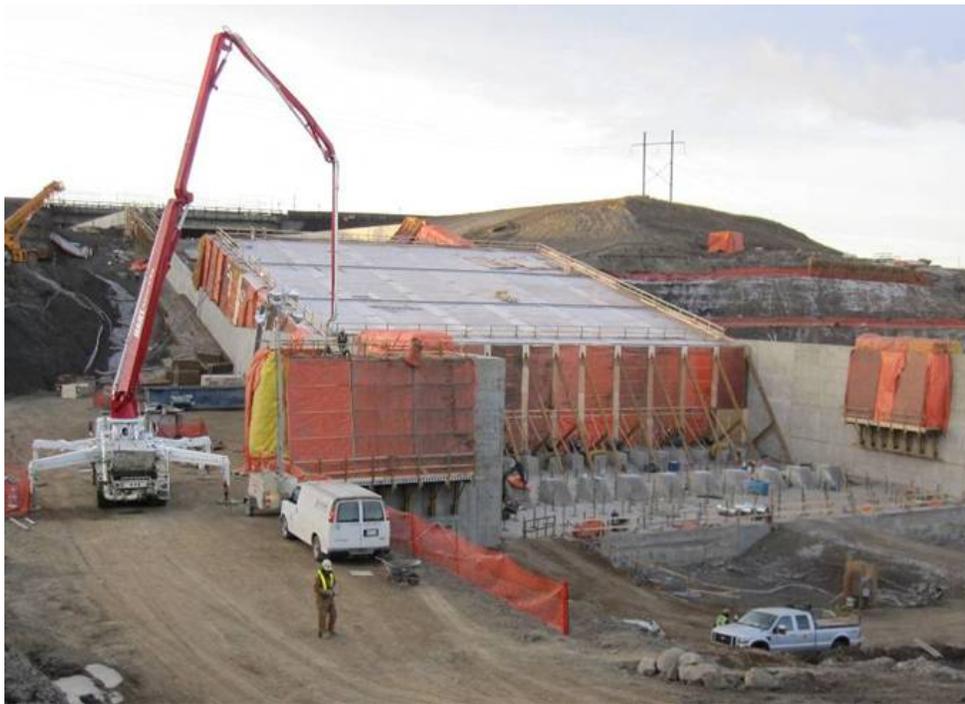
Figure 7: Hoarding for completion of Phase 2 Spillway Concrete and Anchoring in 2010

- Delays at the start of Phase 2, due in part to the passage of flood waters through the spillway, lead to a significant extension to the Phase 2 schedule and resulted in unanticipated winter work. With the need to have the Phase 2 spillway work largely complete for potential flood control in the spring of 2010, extra efforts were required to allow the work to progress right through the winter of 2009/2010. This included the use of a large hoarding enclosure to permit anchor installation and concrete placement in the winter (see Figure 7).

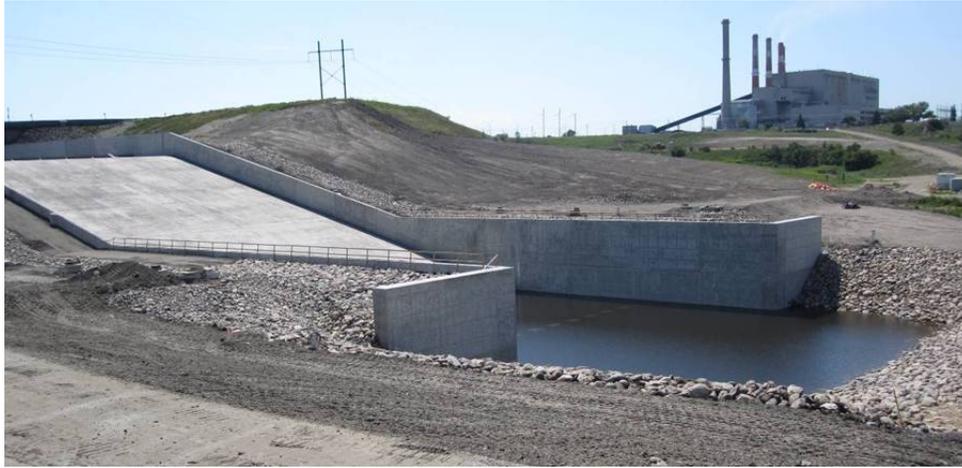
Figure 8: Boundary Dam Spillway Upgrade Completed – Spring of 2010
